**Flood Control Project Maintenance  
Levee Inspections**

## Maintenance Issue Types Only, Levee Inspection Report By Mile - Spring 2017

### Reclamation District No. 2089 Stark

Waterway	Bank	Unit Miles	Inspection Start/End	Inspector
Unit No. 01 Old River	Right	1.51	04/12/2017 04/12/2017	Maksim Khashchuk

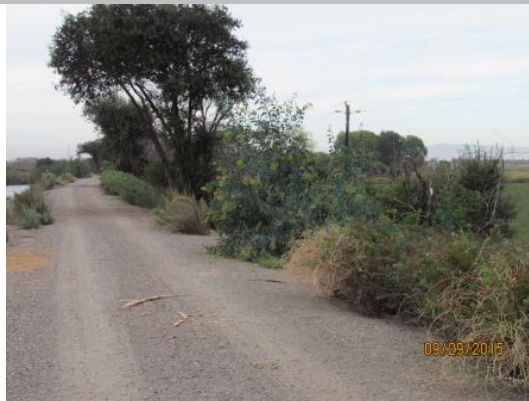
Photo 1 of 1 : SP\_2017\_RD2089\_316\_12\_20170407\_00008.jpg

LM Start	0.27	Rating **	U	Issue No.	12
LM End	0.39	Issue Type +	Ma	Location *	LS
Category	Earthen Levee			GPS Latitude/Longitude	
				Start	End
Item	Vegetation			37.810319 °	37.809740 °
				-121.389510 °	-121.391645 °
DWR ID	DWR_RD2089_01_s_2012_12				
Comment Code					
V2 : Remove the wild growth other than native grasses from the levee slopes.					
Inspector Comment					
Access and visibility completely blocked. 11/10/2011 issue has not changed.

Thick brush and wild rose completely block access and visibility of landside slope and toe.

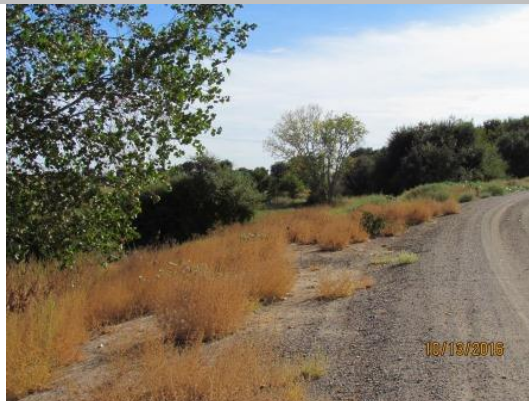
Photo 1 of 1 : SP\_2017\_RD2089\_316\_27\_20170407\_00019.jpg

LM Start	0.47	Rating **	M	Issue No.	27
LM End	0.55	Issue Type +	Ma	Location *	LS
Category	Earthen Levee			GPS Latitude/Longitude	
				Start	End
Item	Vegetation			37.809592 °	37.810136 °
				-121.392993 °	-121.394259 °
DWR ID	DWR_RD2089_01_f_2016_27				
Comment Code					
V2 : Remove the wild growth other than native grasses from the levee slopes.					
Inspector Comment

View of the vegetation on the landside levee slope.

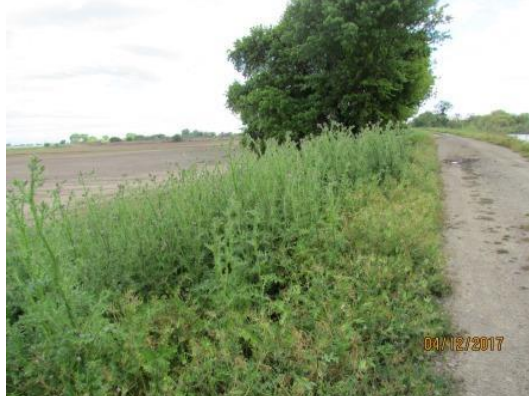
Photo 1 of 1 : SP\_2017\_RD2089\_316\_32\_20170417\_00051.jpg

LM Start	1.06	Rating **	U	Issue No.	32
LM End	1.24	Issue Type +	Ma	Location *	LS
Category	Earthen Levee			GPS Latitude/Longitude	
				Start	End
Item	Vegetation			37.805882 °	37.805847 °
				-121.399790 °	-121.403082 °
DWR ID	DWR_RD2089_01_s_2017_32				
Comment Code					
V2 : Remove the wild growth other than native grasses from the levee slopes.					
Inspector Comment

View of the tall vegetation on the levee slope.

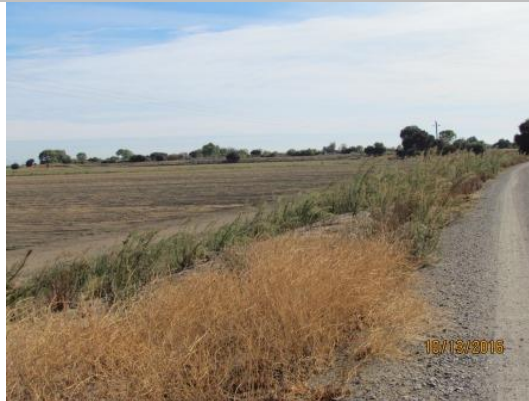
Photo 1 of 1 : SP\_2017\_RD2089\_316\_20\_20170407\_00014.jpg

LM Start	1.25	Rating **	M	Issue No.	20
LM End	1.34	Issue Type +	Ma	Location *	LS
Category	Earthen Levee			GPS Latitude/Longitude	
				Start	End
Item	Vegetation			37.805889 °	37.806148 °
				-121.403153 °	-121.404804 °
DWR ID	DWR_RD2089_01_f_2016_20				
Comment Code					
V1 : Control annual grass and weeds on the levee slopes and easements.					
Inspector Comment

View of the vegetation on the landside levee slope.

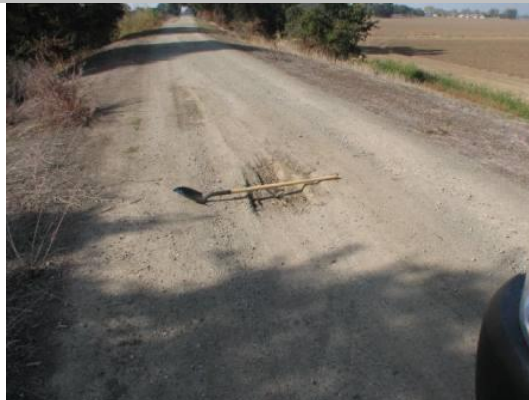
Photo 1 of 1 : SP\_2017\_RD2089\_316\_45\_20170407\_00026.jpg

LM Start	1.34	Rating **	M	Issue No.	45
LM End	1.34	Issue Type +	Ma	Location *	CR
Category	Earthen Levee			GPS Latitude/Longitude	
				Start	End
Item	Crown Surface / Depressions / Rutting			37.806128 °	37.806128 °
				-121.404890 °	-121.404890 °
DWR ID	DWR_RD2089_01_s_2012_45				
Comment Code					
C3 : Add appropriate gravel or road base. Grade and compact.					
Inspector Comment					
11/10/2011 Depression needs to be filled.

11/10/2011 Roadway depression.

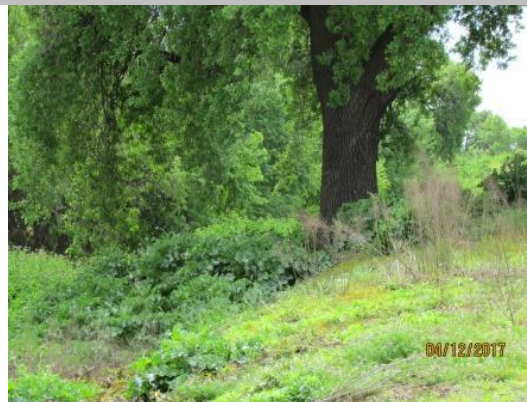
Photo 1 of 1 : SP\_2017\_RD2089\_317\_56\_20170417\_00061.jpg

LM Start	0.07	Rating **	U	Issue No.	56
LM End	0.12	Issue Type +	Ma	Location *	LS
Category	Earthen Levee			GPS Latitude/Longitude	
				Start	End
Item	Vegetation			37.807428 °	37.808070 °
				-121.408749 °	-121.409156 °
DWR ID	DWR_RD2089_02_s_2017_56				
Comment Code					
V1 : Control annual grass and weeds on the levee slopes and easements.					
Inspector Comment					
Remove thistle from the levee slope.

View of the tall vegetation on the levee slope.

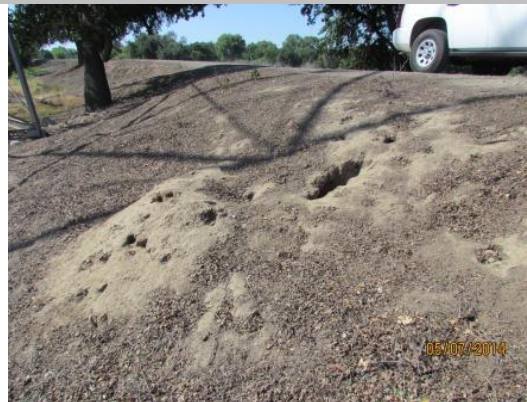
Photo 1 of 1 : SP\_2017\_RD2089\_317\_48\_20170407\_00042.jpg

LM Start	0.16	Rating **	U	Issue No.	48
LM End	0.16	Issue Type +	Ma	Location *	LS
Category	Earthen Levee			GPS Latitude/Longitude	
				Start	End
Item	Animal Control			37.808583 °	37.808583 °
				-121.409432 °	-121.409432 °
DWR ID	DWR_RD2089_02_f_2013_48				
Comment Code					
A3 : No rodents visible, but rodent burrows visible; need to backfill and compact or grout burrows.					
Inspector Comment

View of the rodent burrow on the landside levee slope.

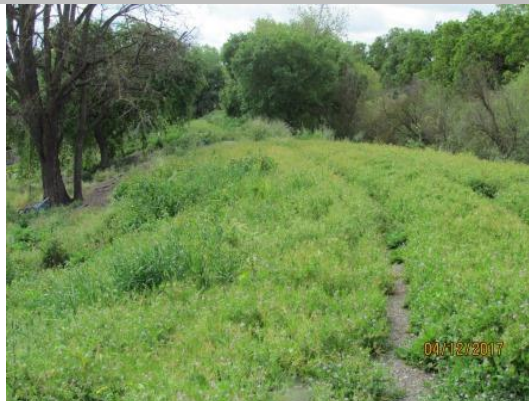
Photo 1 of 1 : SP\_2017\_RD2089\_317\_50\_20170417\_00057.jpg

LM Start	0.84	Rating **	M	Issue No.	50
LM End	1.23	Issue Type +	Ma	Location *	CR
Category	Earthen Levee			GPS Latitude/Longitude	
				Start	End
Item	Vegetation			37.814900 °	37.817976 °
				-121.414698 °	-121.419704 °
DWR ID	DWR_RD2089_02_s_2017_50				
Comment Code					
V1 : Control annual grass and weeds on the levee slopes and easements.					
Inspector Comment

View of the vegetation on the levee crown.

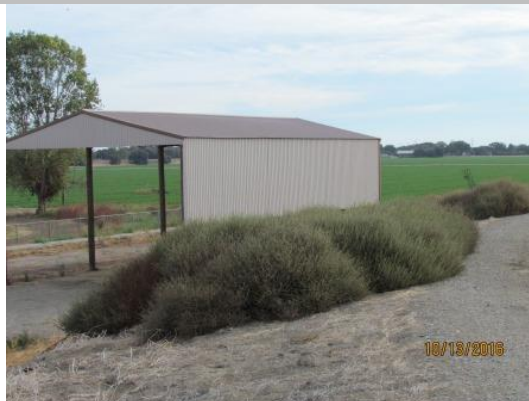
Photo 1 of 1 : SP\_2017\_RD2089\_317\_39\_20170407\_00034.jpg

LM Start	0.85	Rating **	U	Issue No.	39
LM End	0.88	Issue Type +	Ma	Location *	LS
Category	Earthen Levee			GPS Latitude/Longitude	
				Start	End
Item	Vegetation			37.814967 °	37.815017 °
				-121.414839 °	-121.415455 °
DWR ID	DWR_RD2089_02_f_2016_39				
Comment Code					
V2 : Remove the wild growth other than native grasses from the levee slopes.					
Inspector Comment					
Tumbleweeds on landside levee hinge and slope.

View of the vegetation on the landside levee slope.

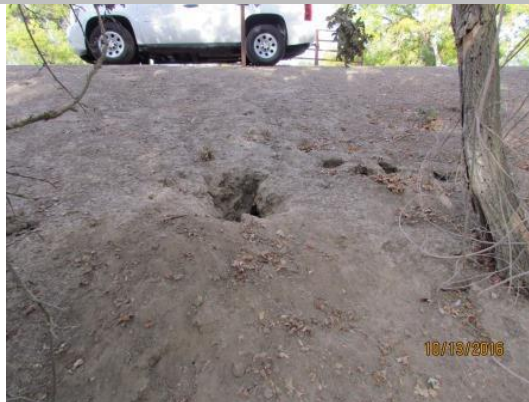
Photo 1 of 1 : SP\_2017\_RD2089\_317\_16\_20170407\_00016.jpg

LM Start	1.30	Rating **	U	Issue No.	16
LM End	1.30	Issue Type +	Ma	Location *	LS
Category	Earthen Levee			GPS Latitude/Longitude	
				Start	End
Item	Animal Control			37.818987 °	37.818987 °
				-121.419767 °	-121.419767 °
DWR ID	DWR_RD2089_02_s_2015_16				
Comment Code					
A1 : Exterminate rodents and backfill and compact or grout burrows.					
Inspector Comment

View of the rodent burrow in the landside levee slope.
